Research and development test on intumescent coating submitted by Unique Products (Thailand) Company Limited

A research and development test were conducted to evaluate the performance of an intumescent coating following procedures based on ASTM E119-24. Please note that this test does not fully comply with ASTM E119-24, as the test specimen was modified to meet the specific research and development objectives of the test sponsor.

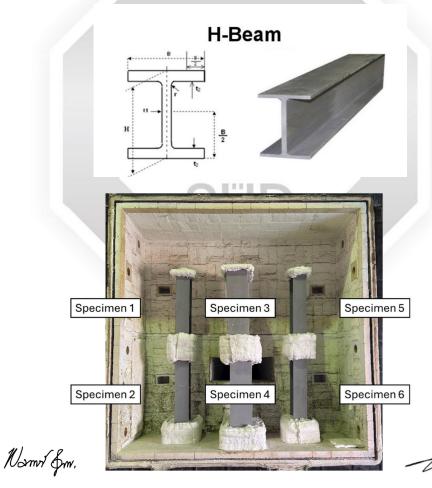
6.1 The test consisted of six H-Beam specimens, each with a height of 100 mm and varying coating thicknesses (Appendix 1). Specimens 1, 2, 5, and 6 had a profile of 200 x 300 mm, while specimens 3 and 4 had a profile of 300 x 700 mm. These specimens were provided by Unique Products (Thailand) Company Limited.

Chasimon No		Profile								
Specimen No.	H (mm)	B (mm)	t <sub>1</sub> (mm)	t <sub>2</sub> (mm)						
1	300	200	20	20						
2	300	200	20	20						
3	700	300	25	25						
4	700	300	25	25						
5	300	200	20	20						
6	300	200	20	20

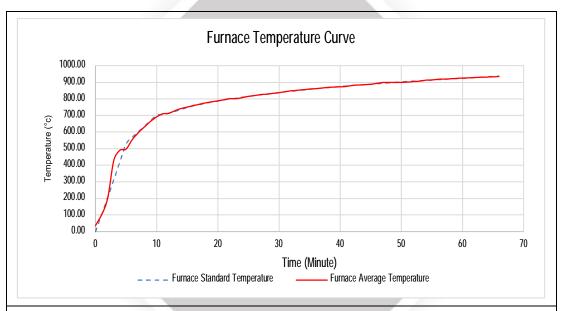
Figure 1: Furnace Time-Temperature vs. Standard Time-Temperature

## Table 1: Comparison of area under the curve

Temperat	ure rise	Area uno	der curve	Percentage	Standard
Time (min)	(°C)		O°)	min)	difference	tolerance
(11111)	Standard	Furnace	Standard	Furnace	(%)	±%
5	527.55	497.04	1566.46	1436.24	-8.31	
10	700.69	690.60	4739.11	4519.82	-4.63	
15	747.69	750.35	8367.10	8163.70	-2.43	10
30	838.03	837.09	20404.32	20204.95	-0.98	
60	924.68	925.94	47042.91	46860.14	-0.39

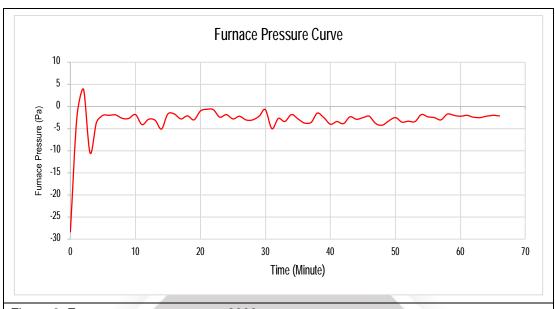
Figure 2: Furnace pressure curve at 2000 mm.

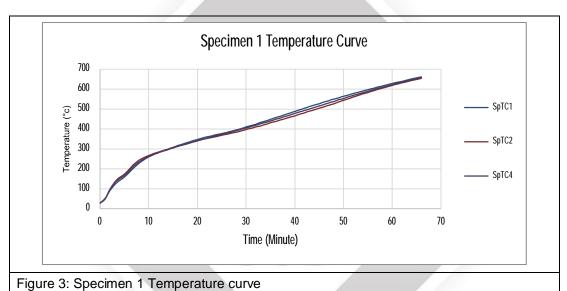
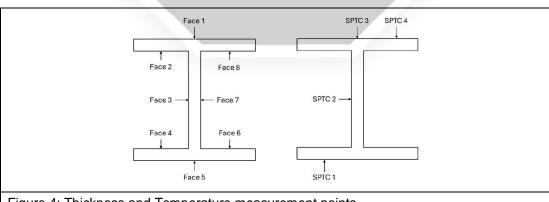
### Specimen 1

Figure 4: Thickness and Temperature measurement points

Specimen No.	Average 538 °C	Maximum 649 °C	Thermocouple rise above 649 °C
1	48 minutes	63 minutes	Sptc No.1 = 651°C
2	66 minutes	66 minutes	-
3	51 minutes	52 minutes	Sptc No.10 = 655°C
4	57 minutes	57 minutes	Sptc No.15 = 653°C
5	56 minutes	66 minutes	-
6	57 minutes	66 minutes	-

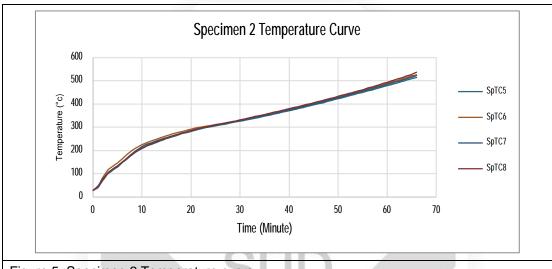
Figure 5: Specimen 2 Temperature curve

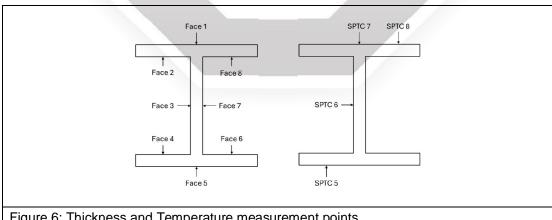
Figure 6: Thickness and Temperature measurement points

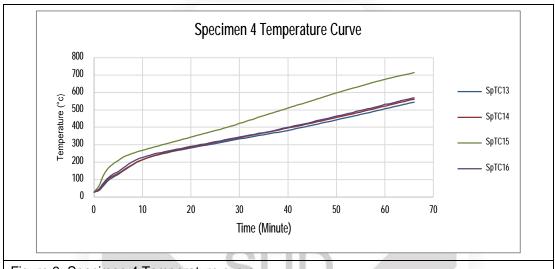
Figure 9: Specimen 4 Temperature curve

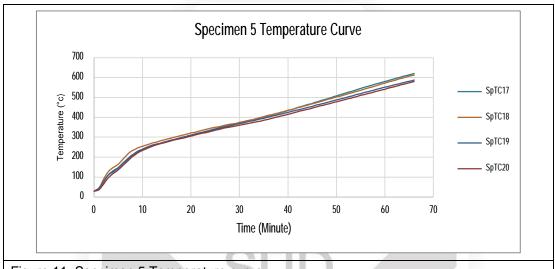
Figure 11: Specimen 5 Temperature curve

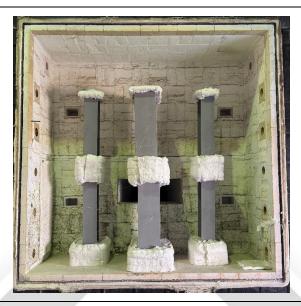
Figure 15: Specimen Pre-test

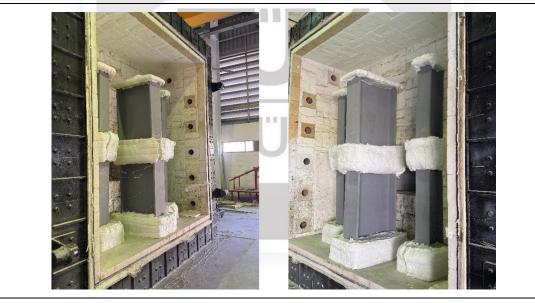
Figure 16: Specimen Pre-test (Cont.)

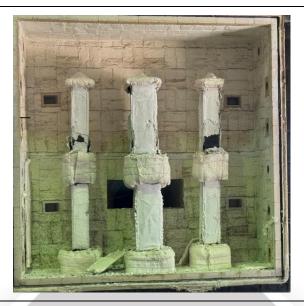
Figure 17: Specimen Post-test

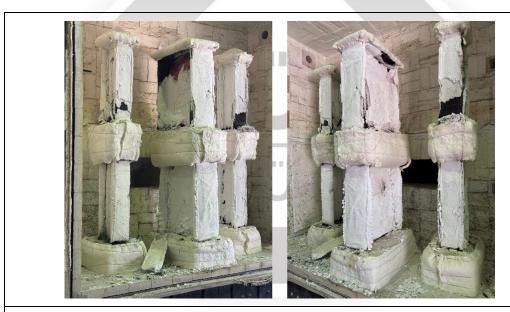
Figure 18: Specimen Post-test (Cont.)
